DECOMMISSIONING OF THE SIMULATION WATER TANK (WETS) AT JAXA TSUKUBA SPACE CENTER

S-086 #456

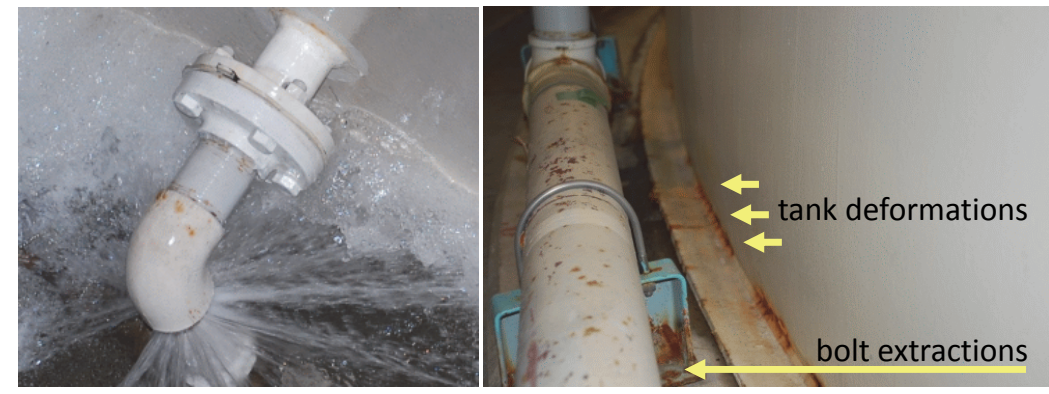
2011 earthquake
 March 11, 2011 quake broke loose an external water circulation pipe coupling; water level came to the bottom **<Fig. 7>**. Although deformation of the tank was minor, assessment led to its removal.

Fig. 7 Tank deformation and pipe bolt extractions.
 Earthquake damage. It took 3 days for the water to drain.

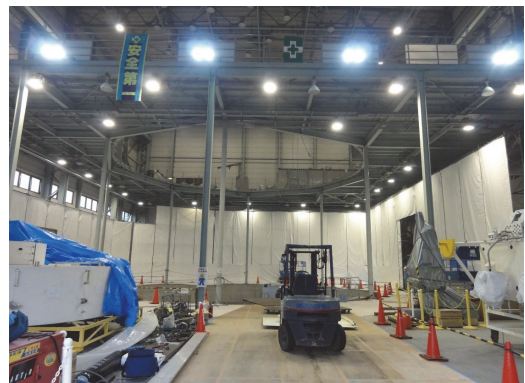
Fig. 9 Vacancy after the demolition.
 Piles were left in the ground.
