# Loss of Signal

*Aeromedical Lessons Learned from the  
STS-107 Columbia Space Shuttle Mishap*

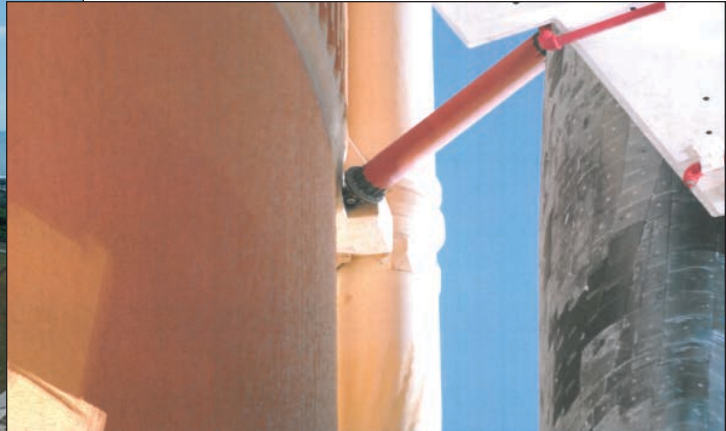
Left Bipod Foam Ramp where the loss of debris occurred on STS-107. Left side is the external tank, and right side is the orbiter.

struck Columbia's left wing on or near a leading edge, an area covered in reinforced carbon-carbon panels because of the extreme heating of this region during reentry. Some analysts expressed concern about this event, given the limited analysis available and the possible implication of such a strike on the TPS and vehicle integrity. Because operational experience with previous foam debris strike events had shown that such strikes had never caused significant structural damage, this event ultimately was not considered mission critical and the flight continued uninterrupted.

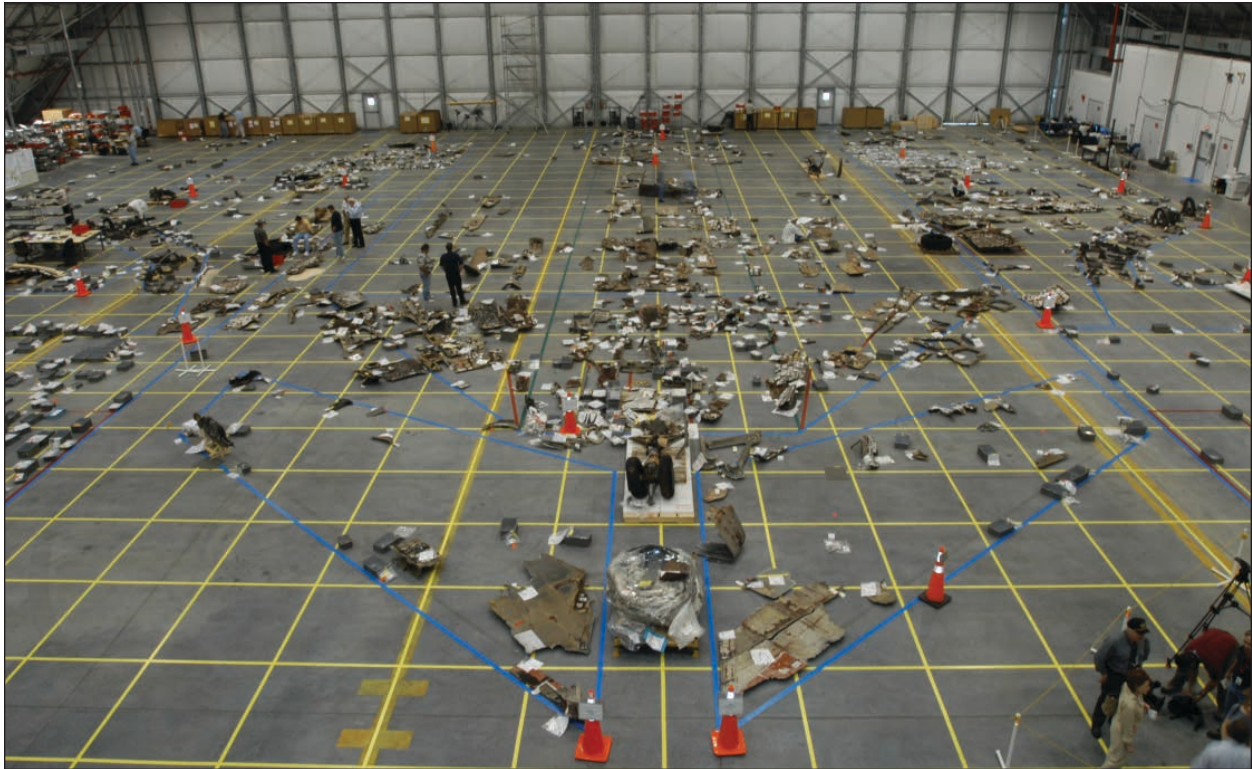
*Reconstruction of the Columbia from parts found in East Texas and western Louisiana. From this layout, NASA was able to determine that a large hole occurred in the leading edge of the wing and identify the burn patterns that eventually led to the destruction of the orbiter.*

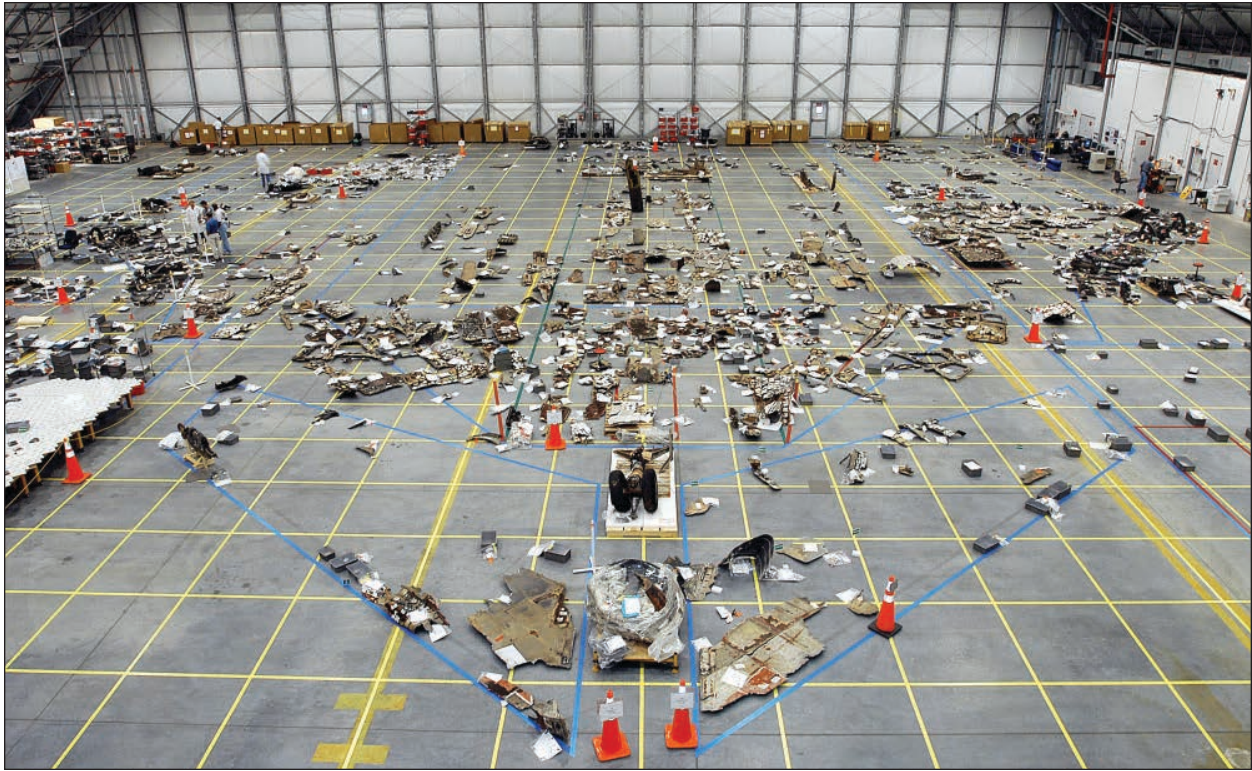
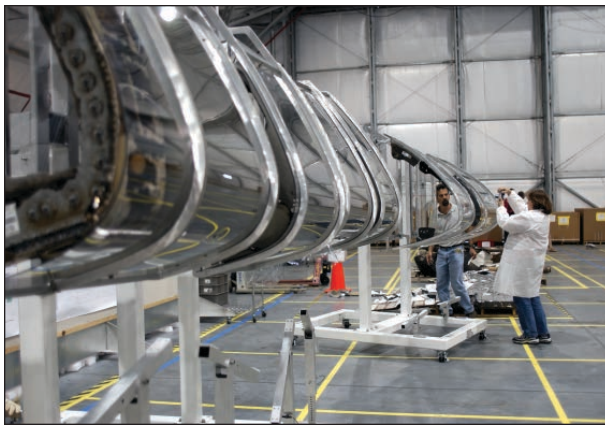
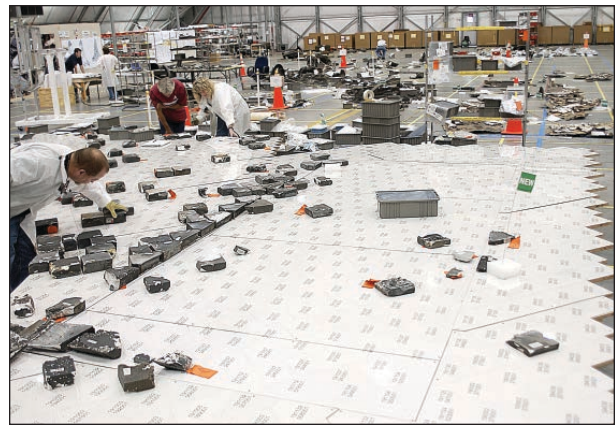
*Inside the Columbia Reconstruction Hangar. Clockwise from top: debris floor grid, wing tile grid table, mockup wing display.*

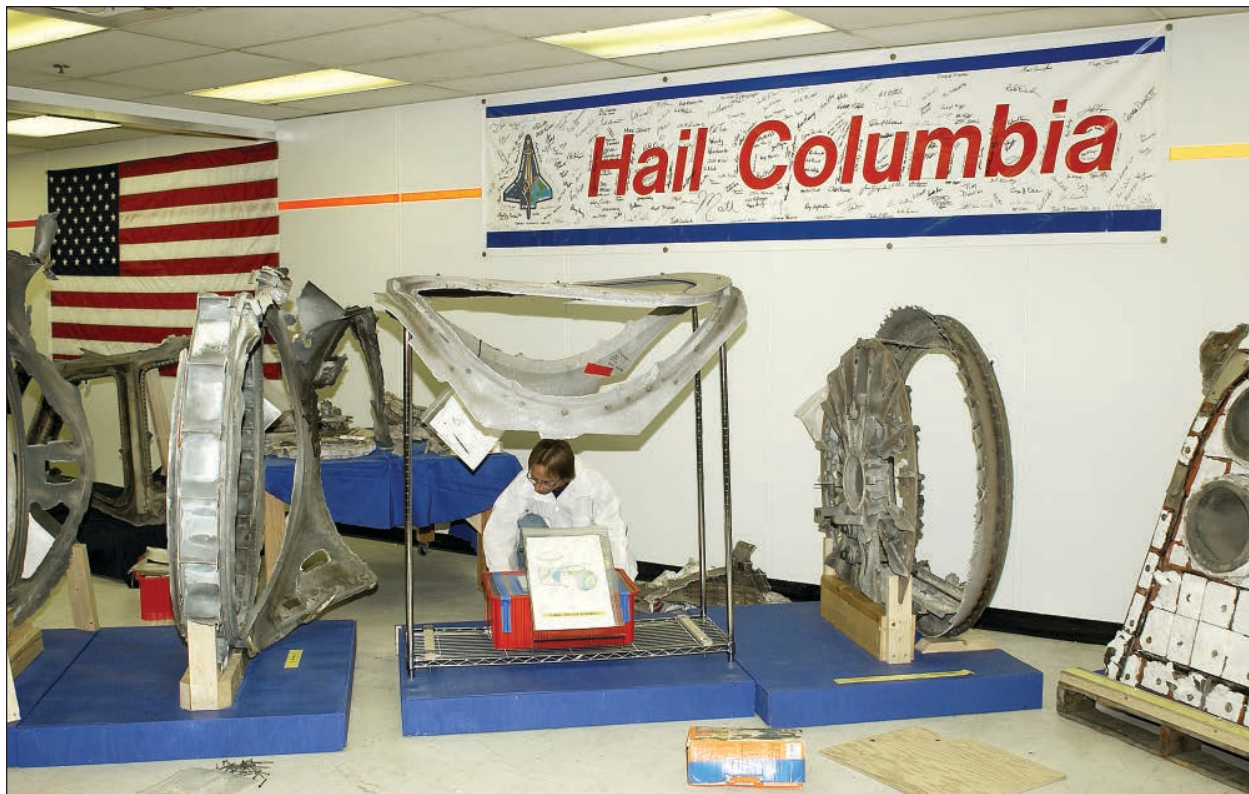
*Unlike the Challenger accident debris, the Columbia debris is accessible for investigation and research.*

The debris from the Challenger accident in 1986 is buried and inaccessible, but NASA decided to honor the Columbia astronauts by allowing the Columbia debris to be readily accessible for investigation and research. In October of 2003, NASA put into effect a plan for long-term storage, designating secure facilities within the KSC Vehicle Assembly Building for the storage and management of recovered items. Columbia items may be loaned to scientific, research, academic, and government entities with an approved justification for use. Scientific studies of the debris have benefited NASA's remaining Shuttle fleet operations and the design of future spacecraft.

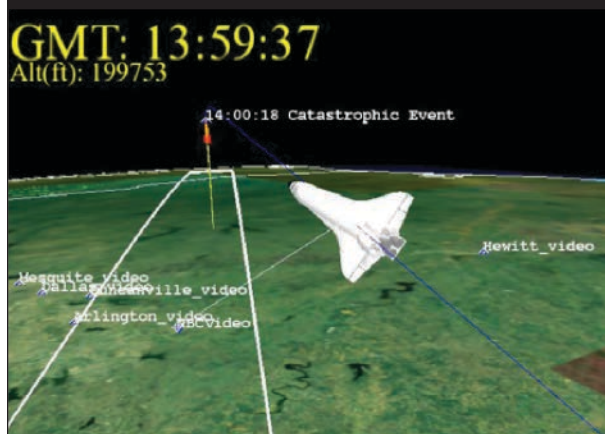
This simulation represents the Orbiter just before loss of control.

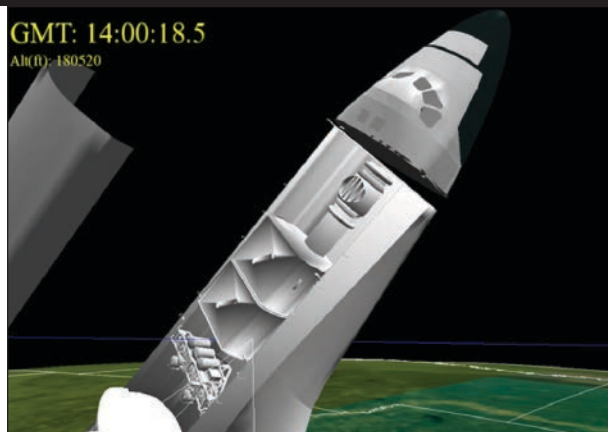
*Based on engineering analysis, the CE is thought to have started with the compromise of the payload bay doors, exposing the payload bay longeron sill to entry heating. The skin splice between the midbody and the Xo 582 ring frame bulkhead area, aft of the starboard x-link, failed due to a combination of mechanical and thermal loads. The forebody rotated away from starboard to port, causing the port x-link to fail due to bending loads. As the forebody separated from the midbody, various power, data, and Environmental Control Life Support Systems lines failed and the crew module was free to move forward and strike the inside of the forward fuselage.*

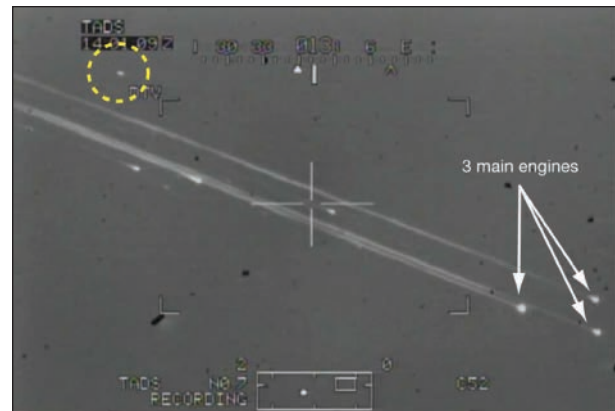
*Image is from the Apache video. Dotted circle indicates area where the crew module debris was last visible. The three points in the lower right are the orbiter's three main engines. The forward fuselage and crew module fragmented into pieces quickly and became too small to detect by ground-based video. At approximately GMT 14:35:00, the crew remains and the majority of the crew module debris completed the free fall to the ground.*

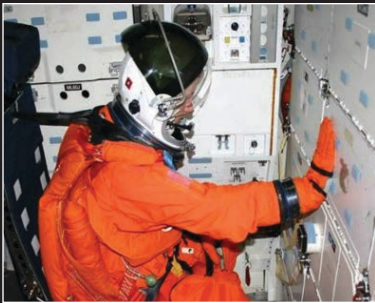
Probably during the catastrophic event, the crewmembers responded to the motion by bracing themselves against structures, resulting in sustained defensive-type injuries. The photos show how the crew may have braced themselves. These injuries indicate that crewmembers were capable of conscious and volitional action up to this point. This bracing caused fractures as illustrated by the schematic showing a wrist fracture.

Demonstration of possible bracing position in the middeck.

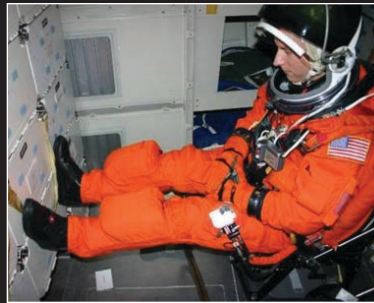
Demonstration of possible bracing position using legs, middeck.

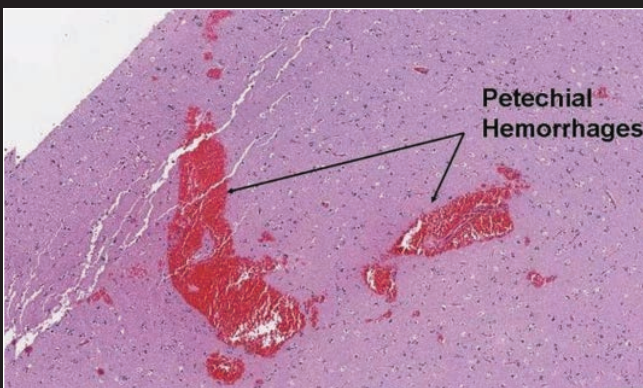
Between the catastrophic event and the crew module catastrophic event, the unconscious crewmembers (with the exception of one crewmember who succumbed to pulmonary barotrauma) sustained mechanical trauma and associated bleeding into soft tissues. Active hemorrhage into injured tissue implies active circulation, as seen in these slides of crewmember neck muscles. This is an important temporal marker for events that occurred antemortem.

*Petechial hemorrhages in neck muscle.*

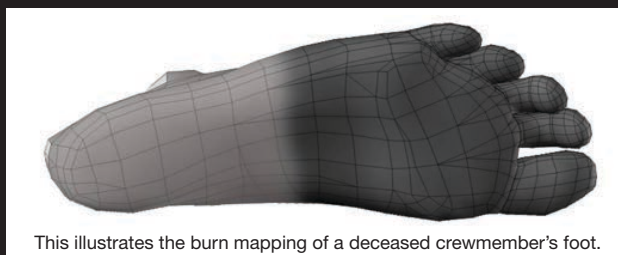
### Burns on the feet

The feet of several crewmembers exhibited thermal injuries in areas coinciding with the nylon panels of the boots vs. the leather portions. These injuries are consistent with initial failure of the nylon panels and boot soles. The feet of several of the crewmembers exhibited a greater degree of burn/material deposition on the forefoot consistent with failure of the boots at the mid-sole. All of these second-degree burns were associated with “molten metal mist” deposits.

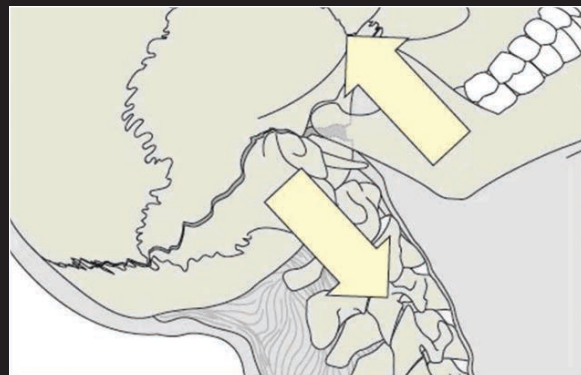
Illustration provided by Biodynamic Research Corporation – BRC

## Plot of Relative Range and Recovery Locations Based on the Ballistic Coefficients of the Principal Human Remains Found on the Ground

those on the port side, suggesting that more energy was imparted to these individuals. This is consistent with the calculated ballistic coefficients of the remains and where the crewmembers were found on the ground during the recovery operations. The ballistic analysis could not be used to determine the sequence and the release times of the crewmembers.

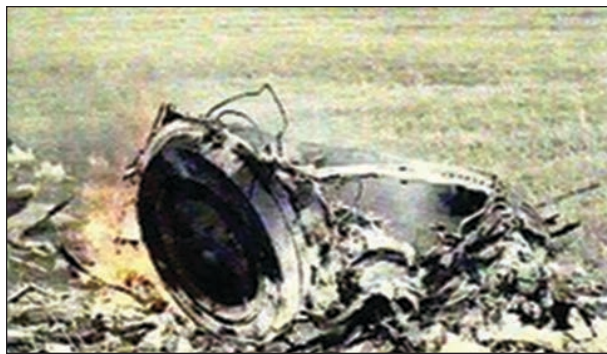
On Soyuz 1 in 1967, both the main and reserve parachutes failed, leading to the death of the crewman. On Apollo 15 in 1971, one of the three main chutes failed, resulting in a slightly harder splashdown landing than normal (32 feet per section (fps) vs. 28 fps), but the seat stroking (load-limiting) mechanisms did not reach

*The Soyuz 1 parachute failures in 1967 resulted in loss of the sole crewman aboard the spacecraft.*

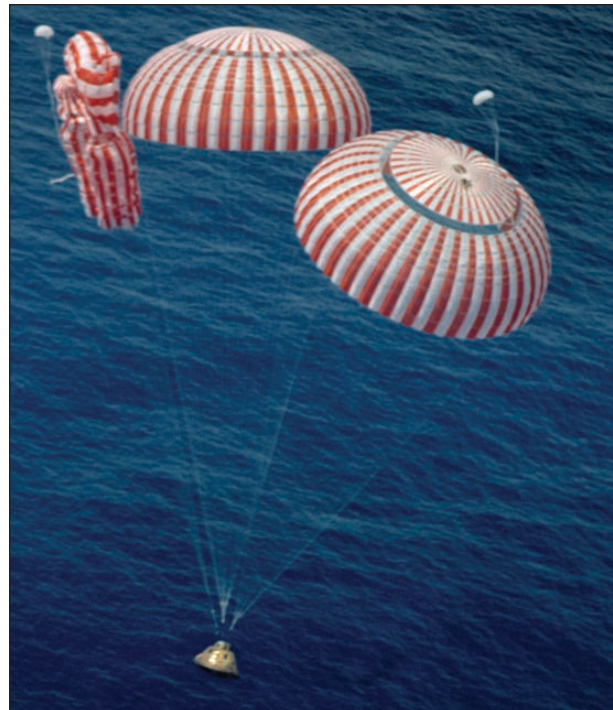
*The Apollo 15 Command Module, with astronauts David R. Scott, commander; Alfred M. Worden, command module pilot; and James B. Irwin, lunar module pilot, aboard, nears a safe touchdown in the mid-Pacific Ocean to conclude a highly successful lunar landing mission. Although causing no harm to the crewmen, one of the three main parachutes failed to function properly. The splashdown occurred at 3:45:53 p.m. (CDT), August 7, 1971, some 330 miles north of Honolulu, Hawaii. The three astronauts were picked up by helicopter and flown to the prime recovery ship USS Okinawa, which was only 6 1/2 miles away.*

activation threshold and no injuries occurred. Possible causes of the parachute failure were

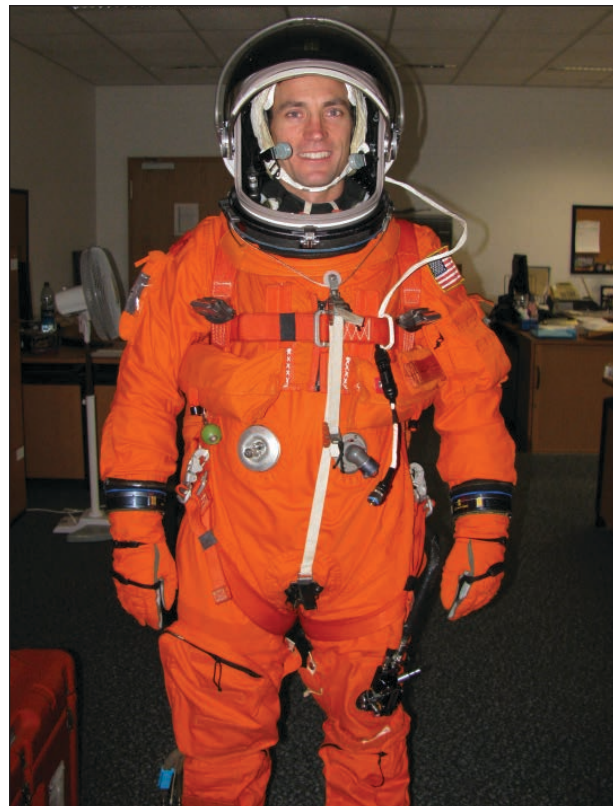
full pressure suit began replacing the Launch Entry Suit. The Shuttle CES was certified to an atmospheric altitude environment up to 100,000 ft. Bailout scenarios were developed for the CES. A bailout below 30,000 ft required stable gliding flight below Mach 1. The plan was for the crew to jettison the Shuttle hatch below 30,000 ft, using the crew escape pole, which allowed them to clear the left wing on exit. Jettisoning the hatch and using the crew escape pole initiated the automatic parachute opening sequence that would deploy the parachute at 14,000 ft.

*In 1994 the David Clark Company Model S1035 Advanced Crew Escape Suit began replacing the S1032 Launch Entry Suit.*
